## LTAC02

Assessment of the stability of 15mm-thick Accoya® cladding boards

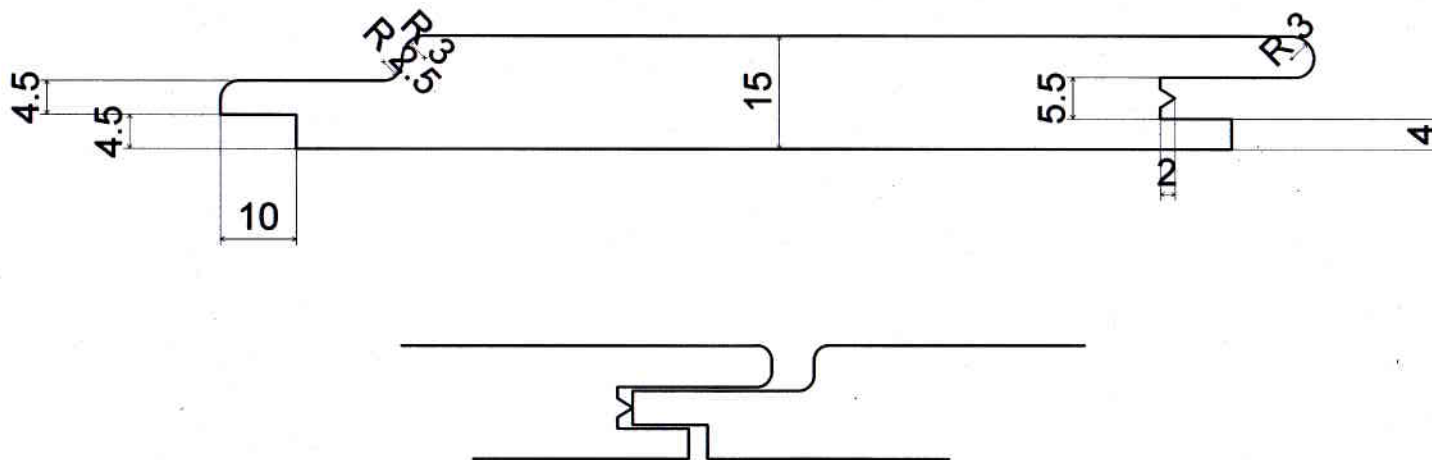
all rads are 2mm
